# Earthquake in Van area – TURKEY

## Preliminary analysis with COSMO-SkyMed images

### e-GEOS

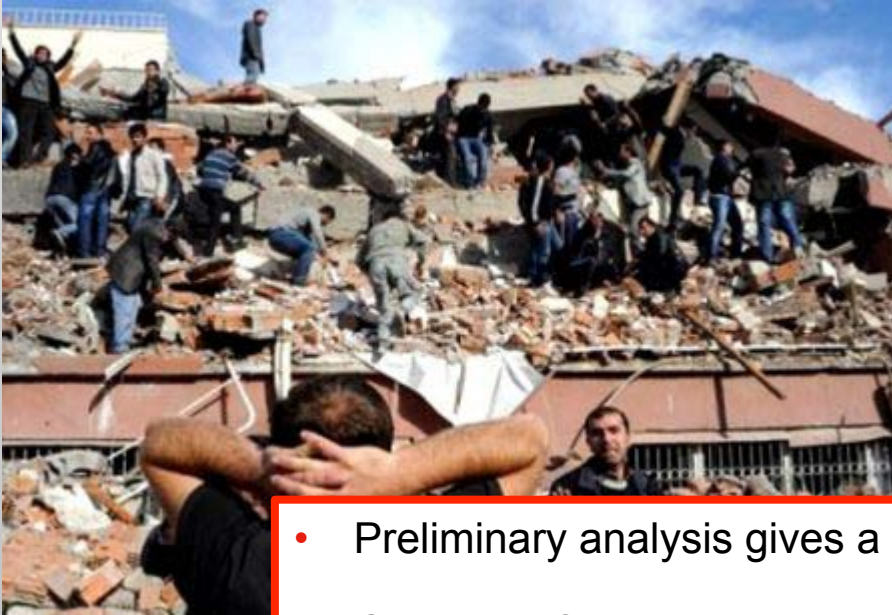
# Van city area

- Preliminary analysis gives a general overview of the affected area
- Ground deformation and movement is identifiable
- Damage to main infrastructure have been highlighted
- Updates and more detailed analysis are possible integrating more data

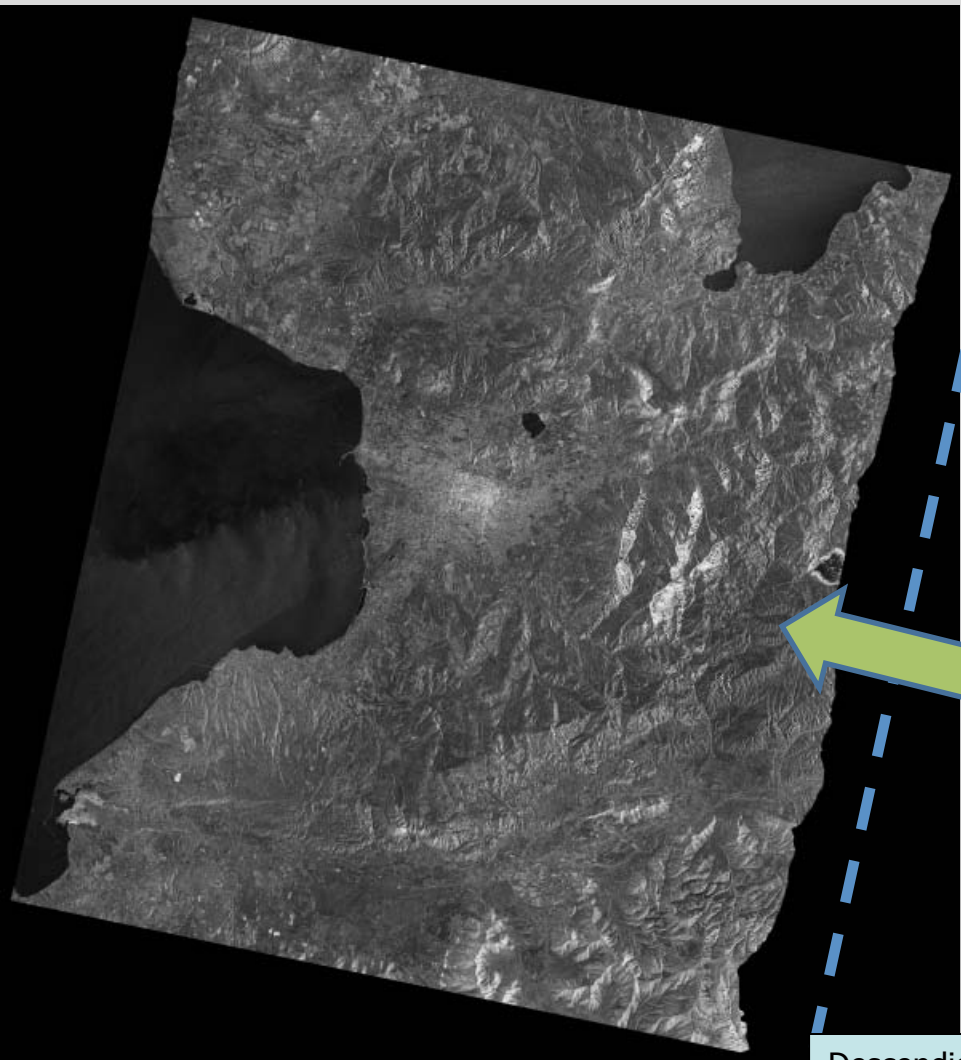
# COSMO – SkyMed VHR Dataset

- Cosmo-SkyMed
- Stripmap mode
- Incidence angle 27.65°
- Descending orbit
- Right looking
- Polarization: HH
- Resolution: 3 meters
- Acquisition dates:
  - 28/09/2011 15:13 UTC (Pre – seismic)
  - 10/10/2011 15:12 (Pre – seismic)
  - Earthquake (23/10/2011 10:41 UTC)
  - 23/10/2011 15:12 UTC (Post – seismic)

Descendig orbit  
Right looking

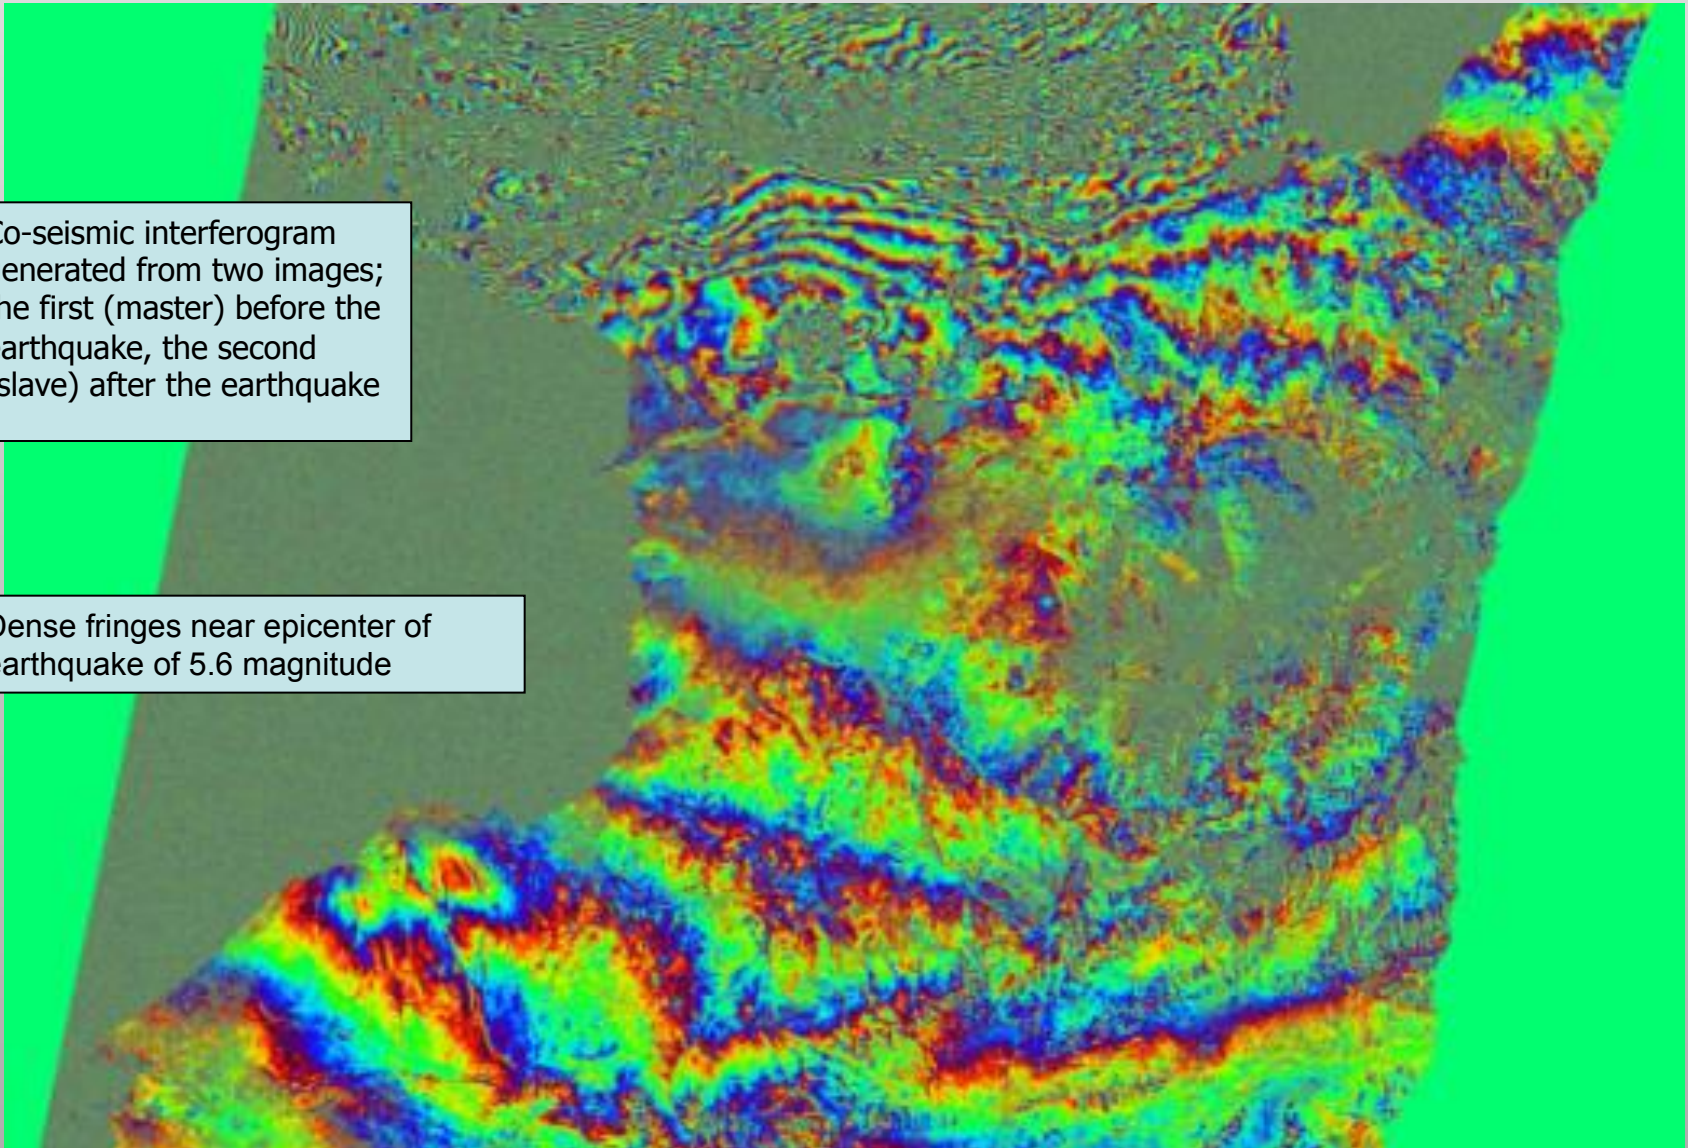
# Co-seismic interferogram (10/10 – 23/10 2011)

Co-seismic interferogram generated from two images; the first (master) before the earthquake, the second (slave) after the earthquake

Dense fringes near epicenter of earthquake of 5.6 magnitude

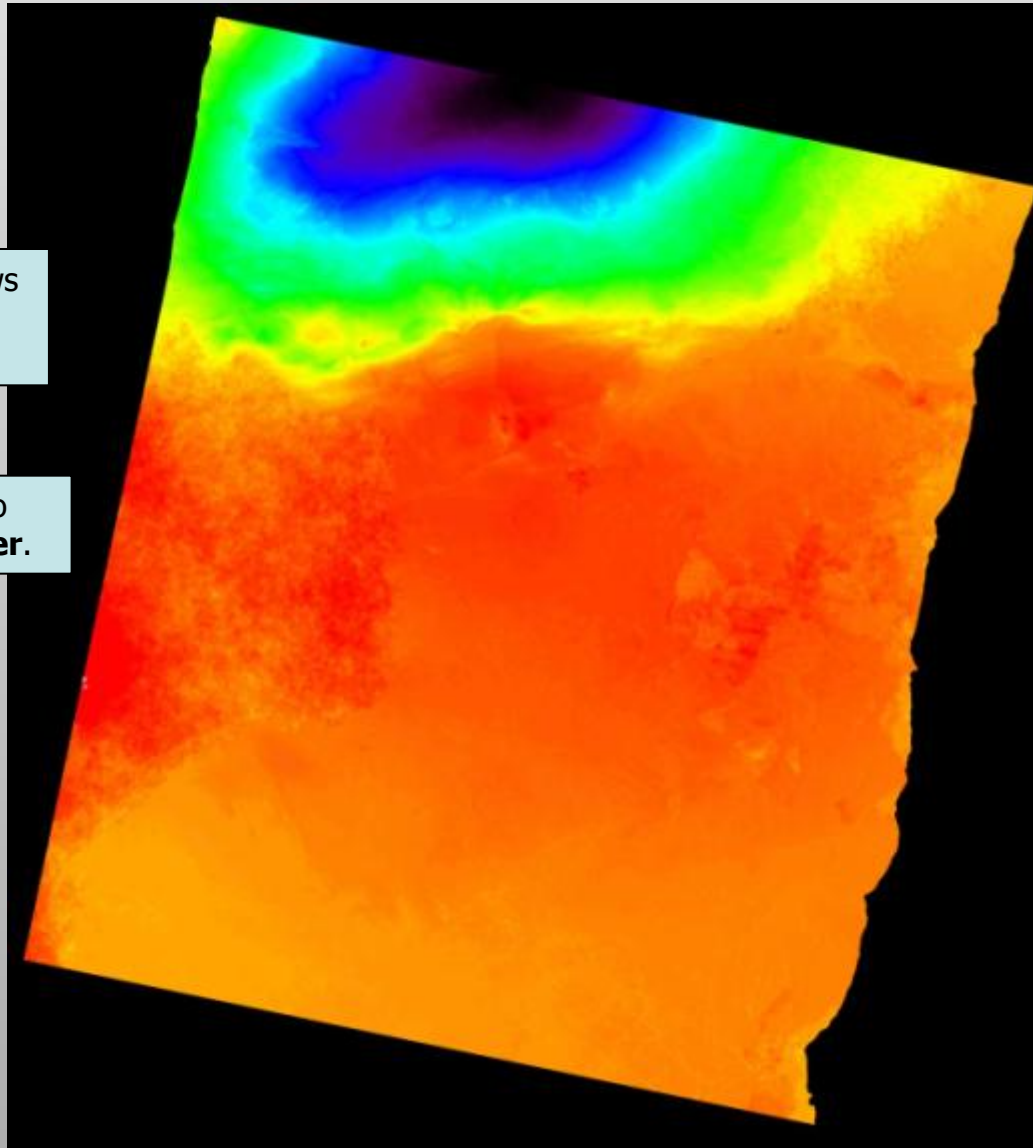
# Co-seismic interferogram (10/10 – 23/10 2011)

Unwrapped phase shows displacements of the terrain.

The range from black to orange is about **1 meter**.

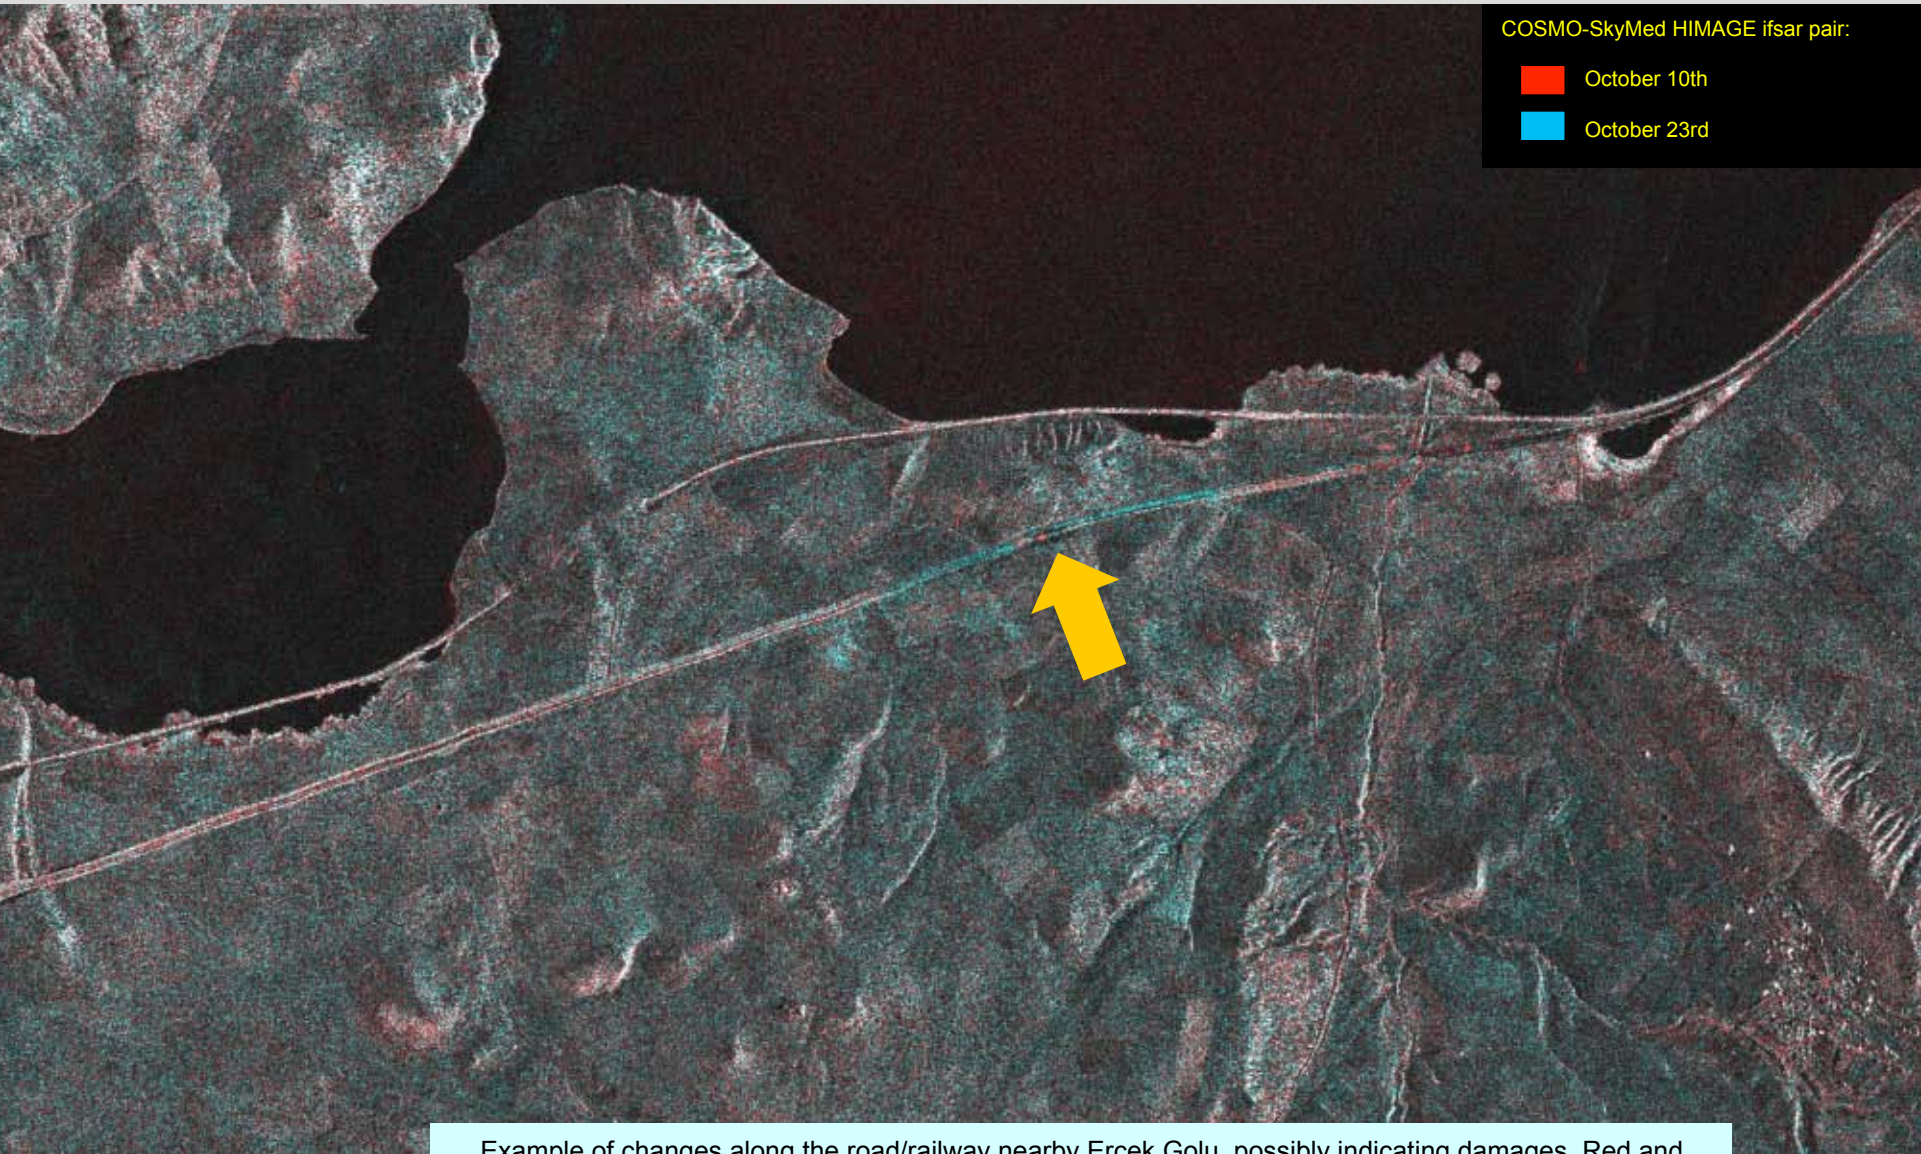
# Change Detection: 10 - 23/10/2011

Example of changes along the road/railway nearby Ercek Golu, possibly indicating damages. Red and cyan targets indicate changes occurred during the time interval between acquisitions.

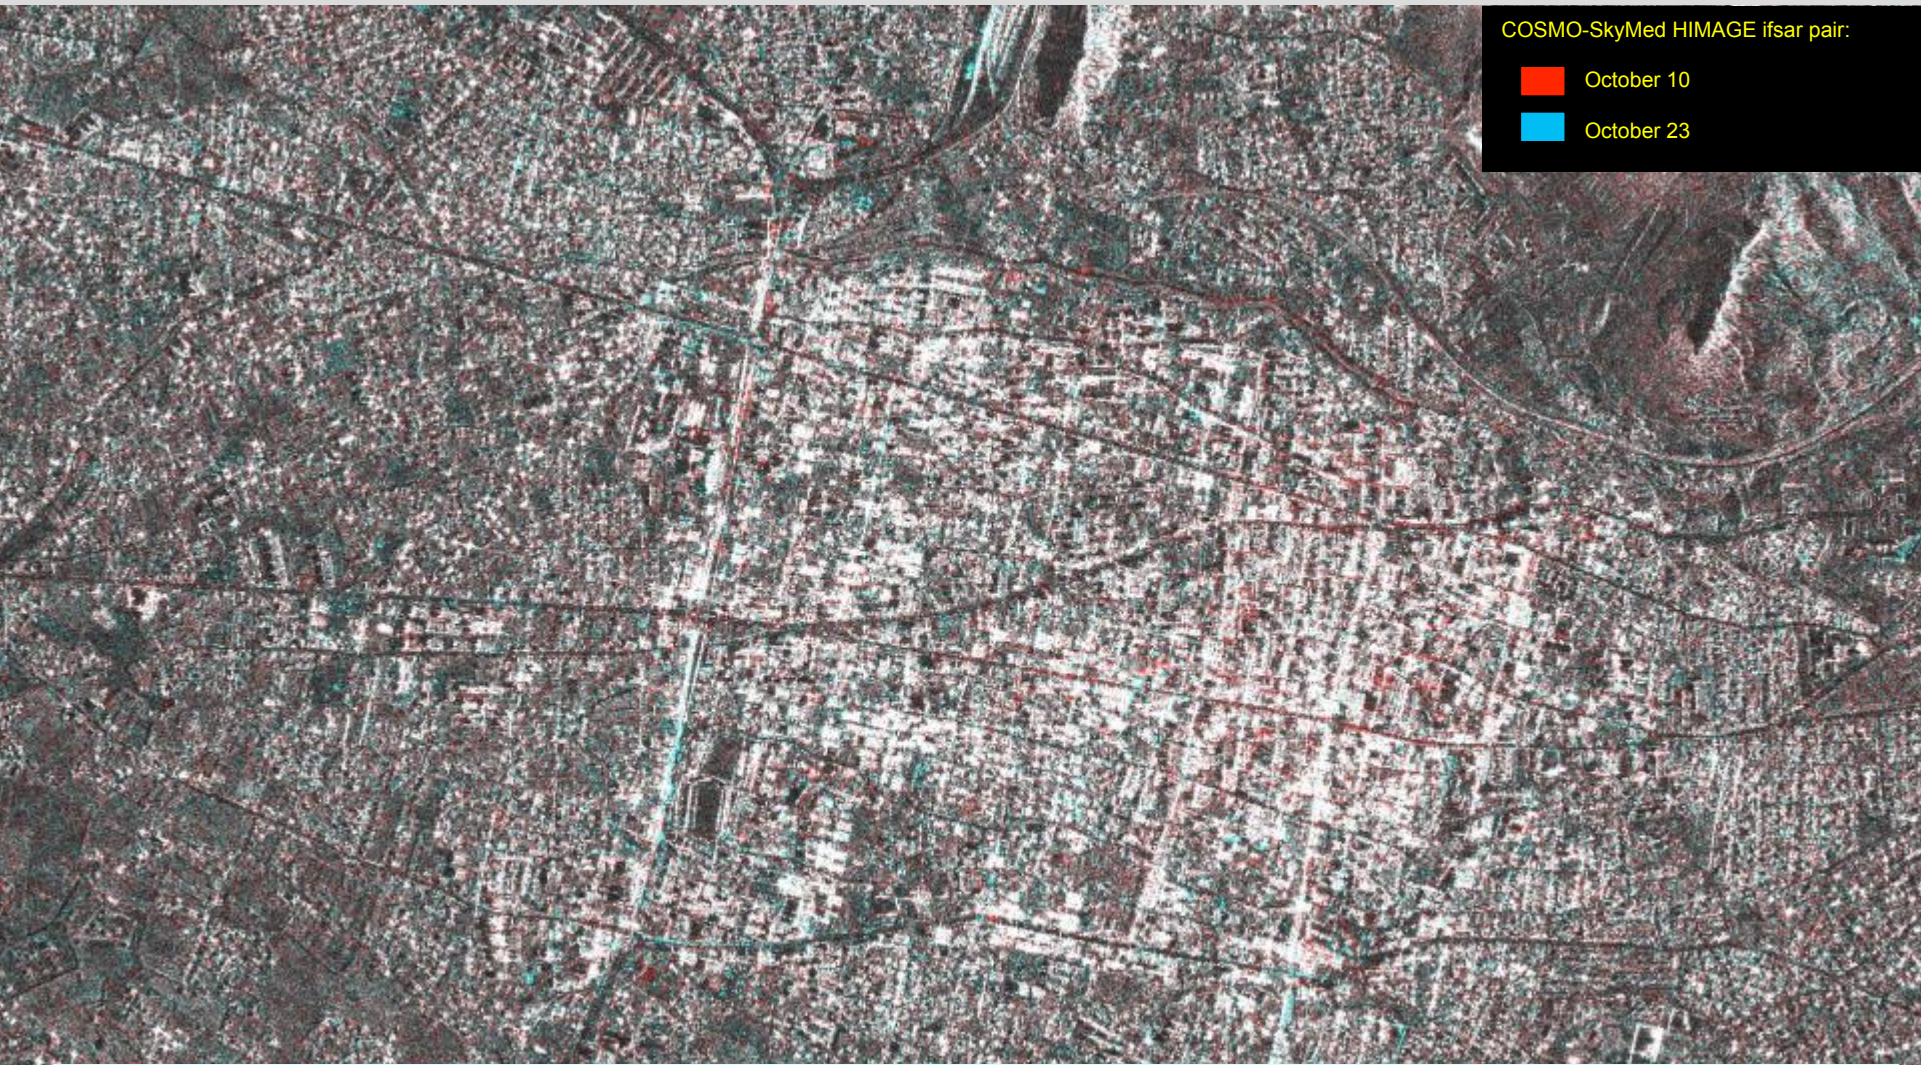
# Change Detection: 10 - 23/10/2011

False colour composite made up of two COSMO-SkyMed Stripmap images (the oldest in red and the most recent in cyan) of a detail of the city of Van. White targets indicates structures present in both images, while red and cyan targets indicate changes during the time interval between acquisitions.

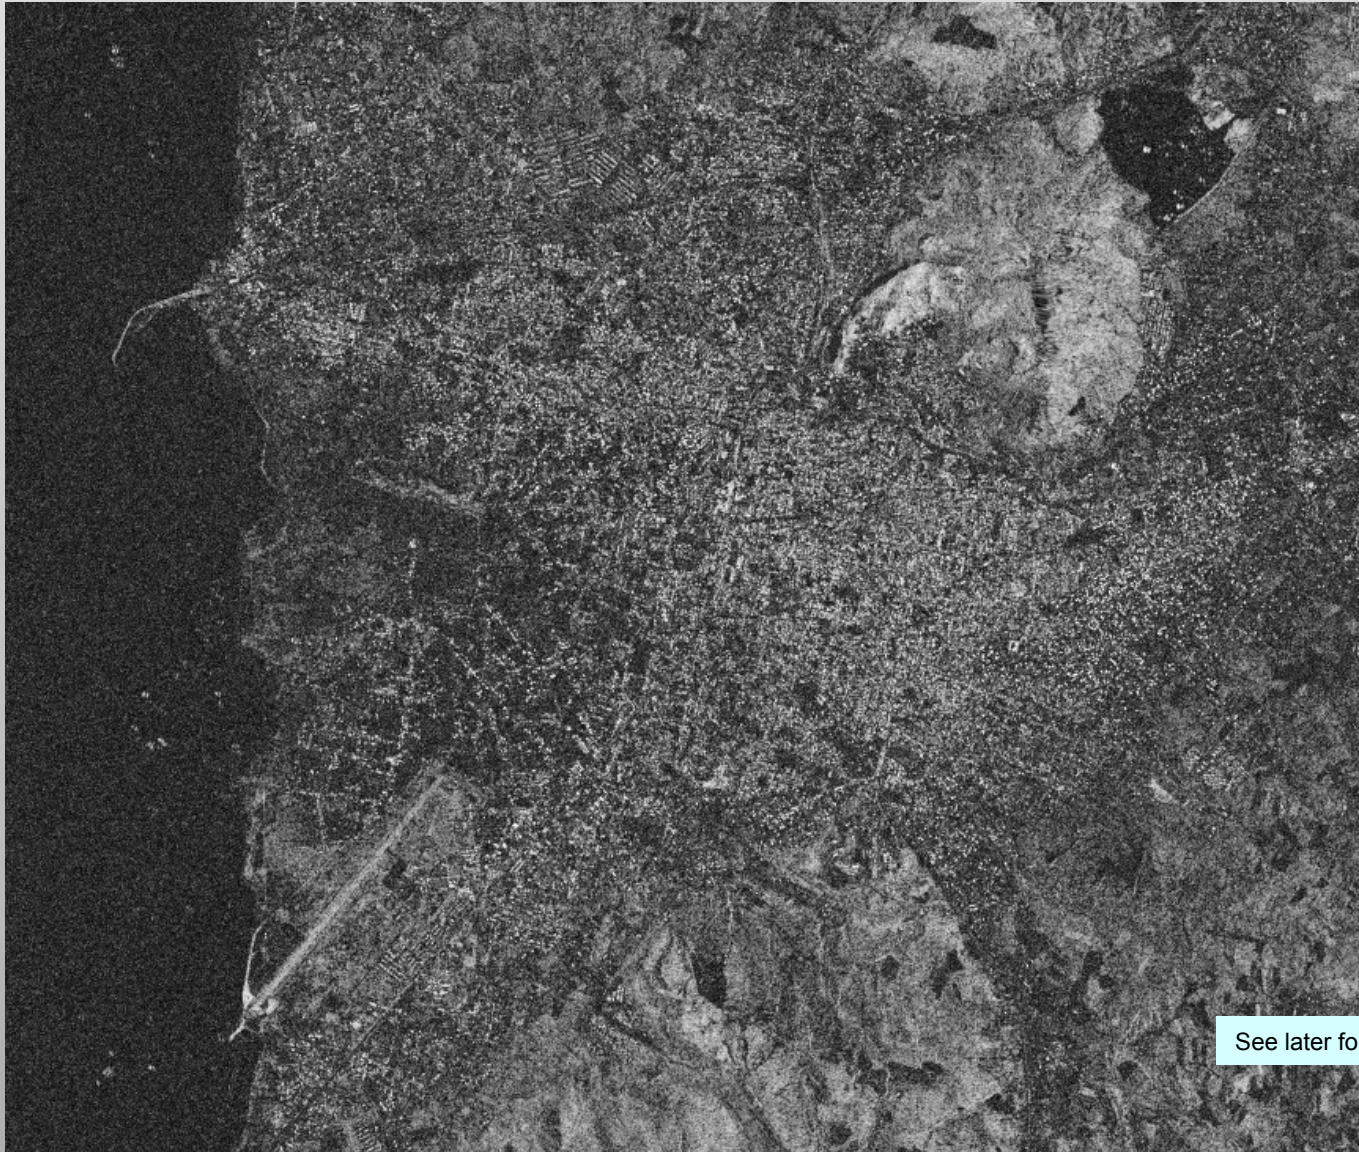
# Co-Seismic Coherence: 10/10/2011 – 23/10/2011

There is a general decrease of the coherence value in the co-seismic map that might be interpreted as an effect of the earthquake.
